WARNING – Incorrect wiring diagram in the rev hub guide document.

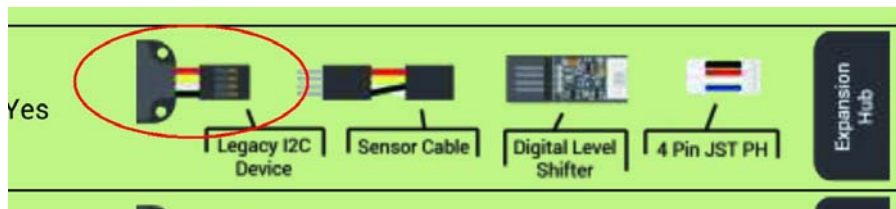
Figure 7: Connecting a Legacy 5V Sensor to an Expansion

On page 18 and page 19 of the hub guide document there is an error depicted in the wiring of Modern Robotics sensors that is incorrect and misleading some teams when trying to use their existing sensors.

In the 2 examples above it shows the Modern Robotics Sensor viewed from the top with the black wire on the bottom when all sensors viewed from the top have the black wire on the top. The orientation of the connector is correct but the wiring is reversed.
